A Naval Safety Center Publication

approach

JULY 1972 THE NAVAL AVIATION SAFETY REVIEW

Fire in Flight

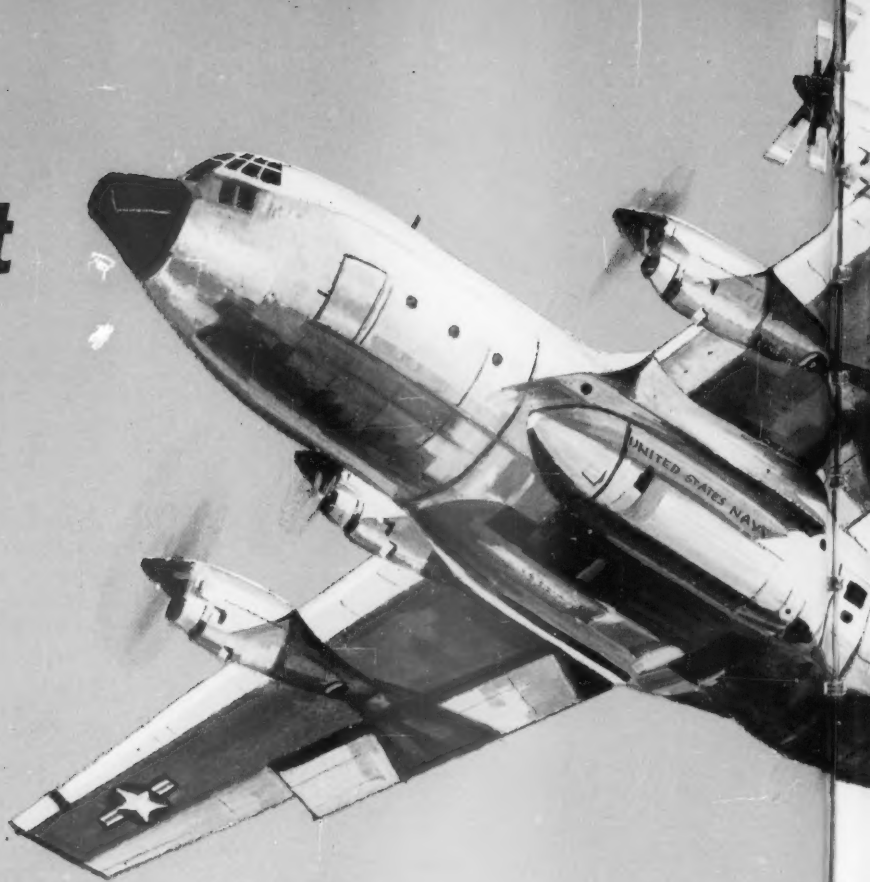
Living with an aircraft discrepancy is like living with a snake; both have a tendency to rise up and strike you when you least expect it.

The most probable cause of the fire was a short in the cannon plug for the No. 1 fuel quantity gage. This allowed 115 volts a.c. current to be routed to the internal fuel tank wiring. An arc or spark apparently jumped from the wiring to ground at some point in the tank.

Such an arc or spark would not cause an explosion or fire if submerged in fuel. However, it is suspected that sufficient fuel had been burned to leave space above the fuel which contained a suitable fuel-air mixture for ignition by the arc. (Refer to NAVSAFECEN Flight Advisory 5-72, reprinted in the accompanying box.)

Investigation revealed an uncorrected aircraft discrepancy of long standing, i.e., a malfunctioning fuel tank indicator which was first griped more than 2 months before the accident. This discrepancy was not considered cause for downing the aircraft. The yellow sheet discrepancy read, "No. 1 main fuel tank reads off scale at all times." Corrective action read, "Repaired coax cable, checks good," and "Repaired cannon plug, checked good."

For NAVAIRSYSCOMHQ: Recommend that maintenance procedures for correcting fuel quantity indication discrepancies be revised to provide that any fuel quantity indicator with a known discrepancy be disabled before release for flight or before ground maintenance by pulling and tagging the indicator circuit breaker where applicable. Further recommend prohibit inflight troubleshooting of fuel quantity indicating system which would involve connecting or disconnecting cannon plugs.

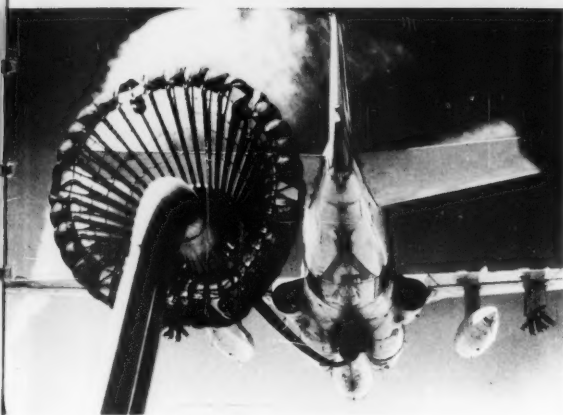
A standing wave was set up in the hose. The MA2 coupling failed and the basket separated from the hose. The hose whipped violently and sprayed fuel over the

The jettison attempt failed to separate hose from aircraft. During subsequent landing rollout at homebase, the trailing hose snagged the arresting gear and separated from the aircraft. Postflight inspection revealed that the guillotine had fired, but merely crimped the hose. The hose tore off at the aft (second) crimp. A safety UR was submitted on the guillotine device.

The cause of this mishap was pilot error (wingman of receiving aircraft) in that he did not adhere to prescribed procedures. He left his position in the flight *without* clearance and attempted to engage the drogue *without* clearance from the tanker. Fuel ingestion caused explosions which resulted in limited damage to his aircraft.

The reporting command stated that the wingman exhibited a lack of flight discipline. Likewise, the flight leader demonstrated a lack of flight leadership. Both pilots were scheduled for additional training.

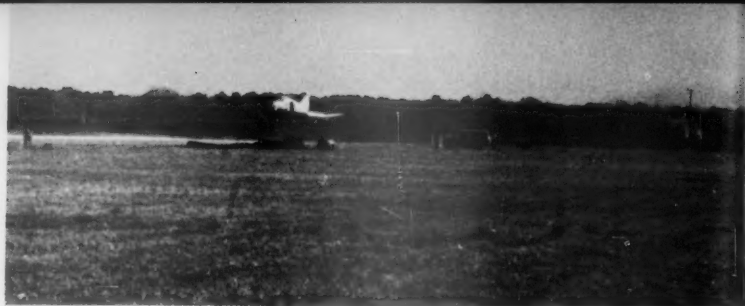
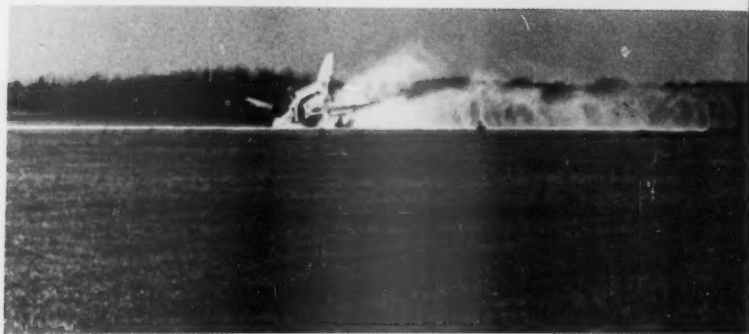
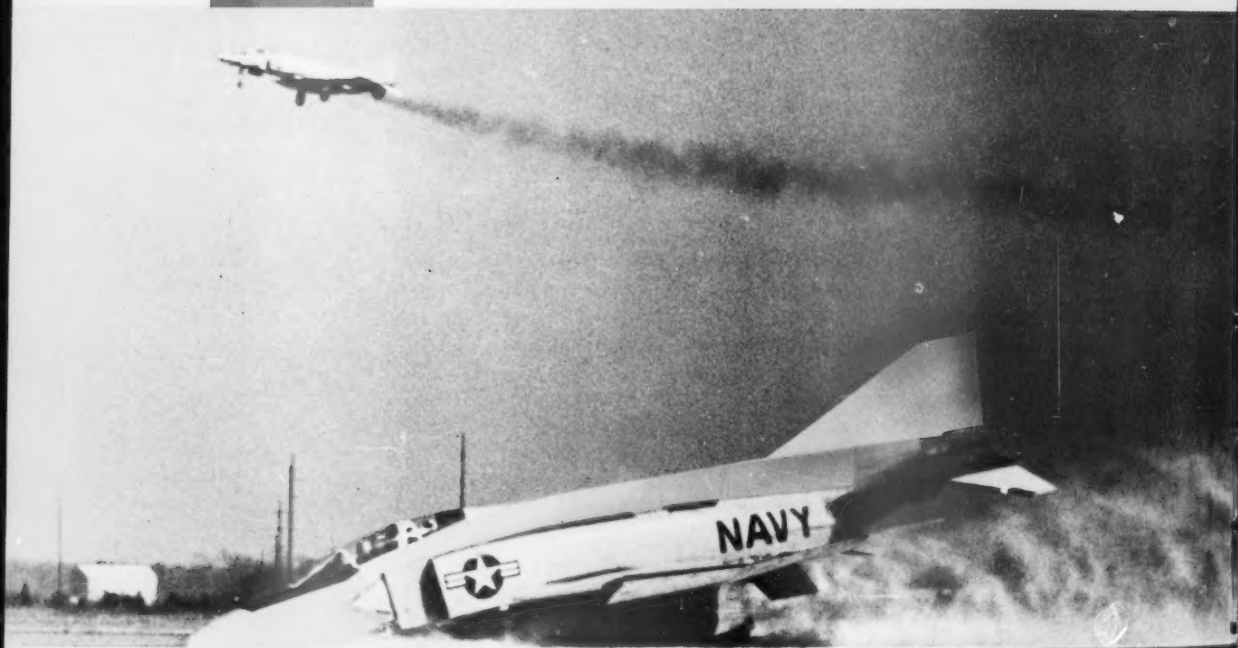
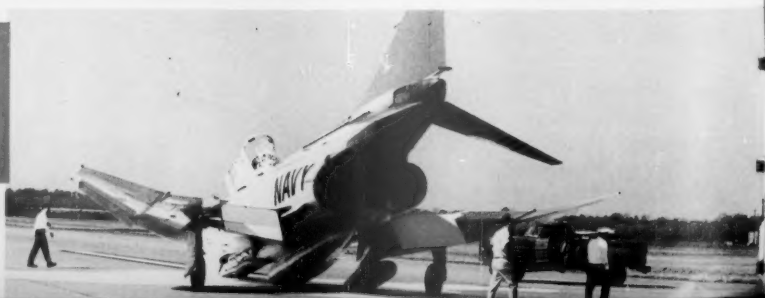
After the runway was prepared, the pilot turned off the 180 with 2600 lbs of fuel. He flew the approach exactly as briefed. (See photos.) After touchdown, the nose was eased onto the foamed runway and the engines were secured. The drag chute was not deployed because of a crosswind which might have made it difficult to keep the aircraft aligned on the foam. The *Phantom* came to rest about 5000 feet from touchdown, less than 5 feet off centerline. The pilot was uninjured. Damage was limited to the centerline tank and the underside of the nose.

Investigation into the causes behind the failure of the nose gear to extend revealed that the bolt on the rod-end of the nose gear uplock actuator was not as specified by MIMs. The bolt installed was of a lower tensile/shear strength than that specified and presumably was overstressed when torqued as prescribed for the stronger bolt. Installation of this bogus bolt and/or possible overstress caused its eventual failure and subsequently the rod fork. This caused the NLG to remain up and locked, with landing damage an unavoidable consequence.

"Once again we are reminded of the importance of proper aircraft maintenance procedures. It is imperative that all aircraft maintenance personnel ensure use of nuts, bolts, cotter keys, etc., which meet the required specifications when replacing any aircraft part and that quality assurance/control personnel verify such procedures."

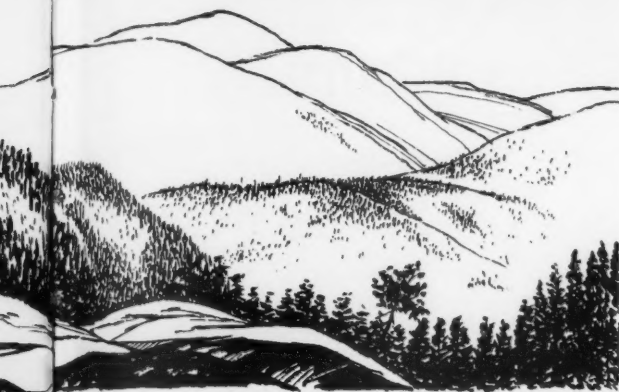
• From the air, terrain slope in the impact area is easily underestimated and gives the illusion of a gradual incline. This illusion combined with the nosehigh attitude of the aircraft could easily give the pilot a false sense of security.

• The pilot under instruction (rear seat) was under the hood and was performing a practice penetration/GCA/missed approach. The illusion of gently rising terrain, as opposed to the actual steeply rising terrain, may have lulled the instructor pilot into a false belief that the ridge could be easily cleared. This false sense of security was possibly reinforced by the nosehigh attitude of the aircraft during the missed approach. In addition, and perhaps most important, the instructor pilot may have seriously overestimated the climb performance of the aircraft under existing conditions. In the past, most practice missed approaches had been performed at 3000 feet MSL where waveoff characteristics of the TA-4J are significantly greater than those at 8000 feet.

One recommendation is obvious. Pilots should guard against flying, and supervisors should guard against letting them fly, when ill or overtired. A second recommendation is valid, but less obvious. Whenever a change in the operating environment occurs, all concerned should be quick to assess its probable impact on current operations.

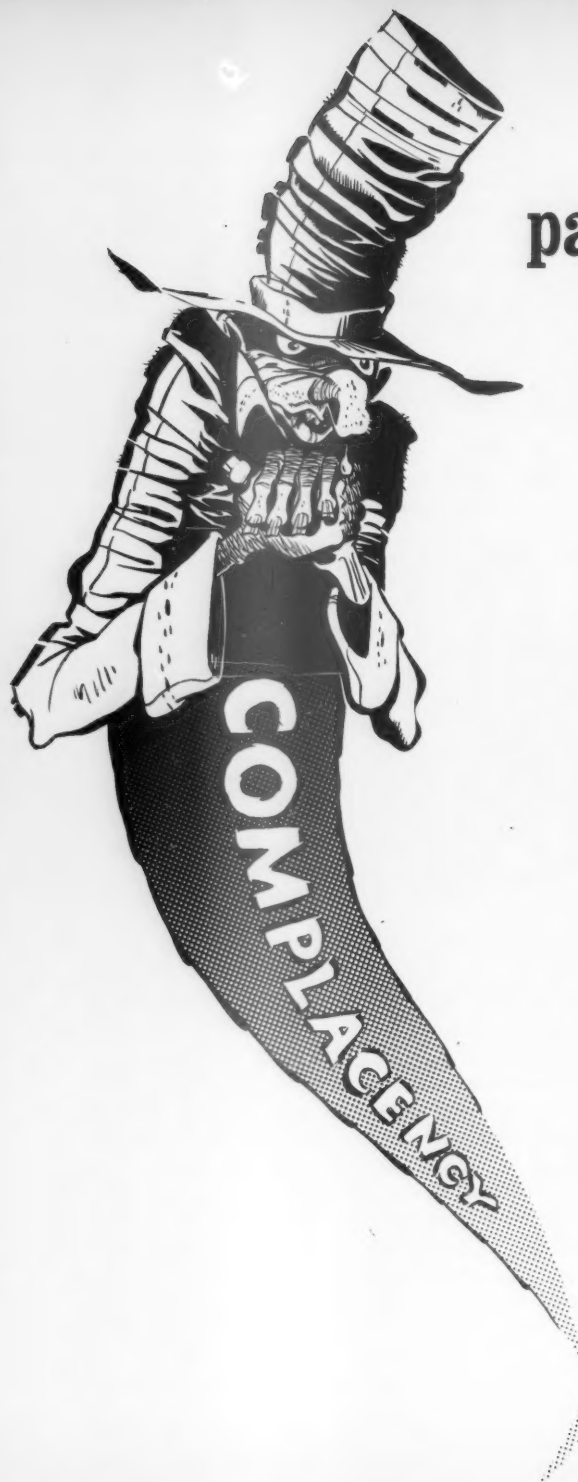
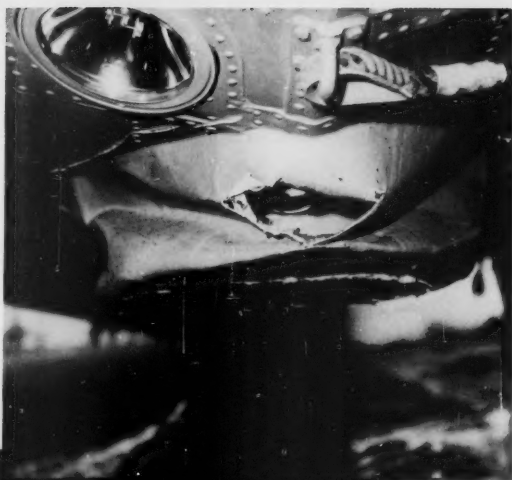
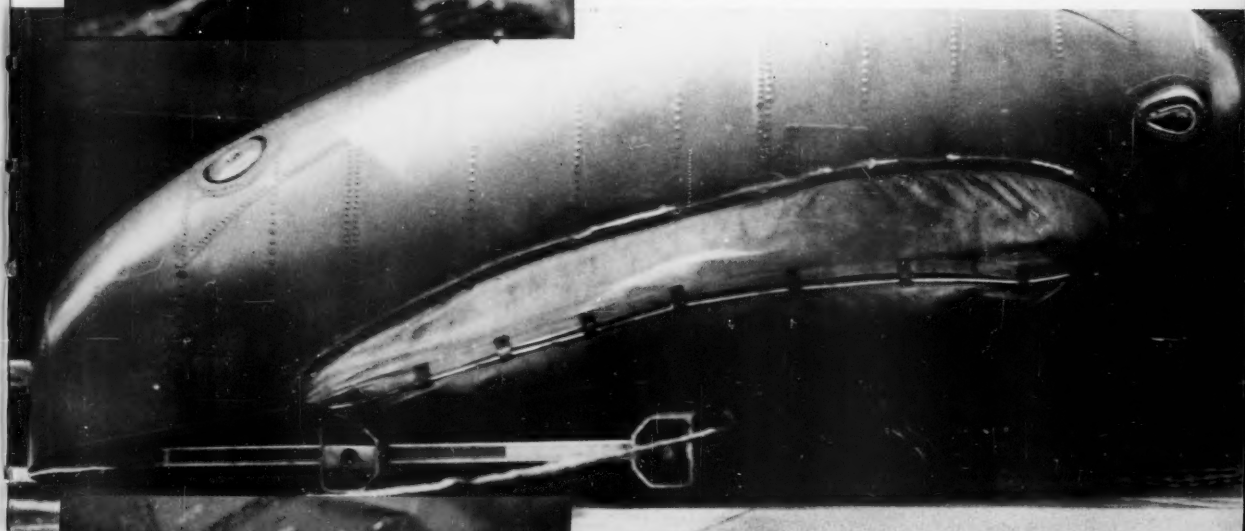
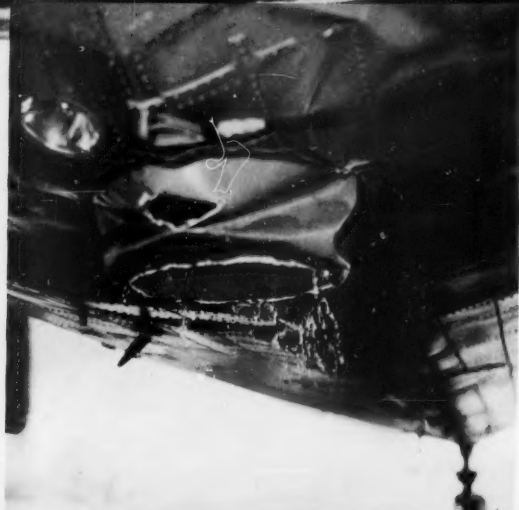
Initial turnup of the No. 1 engine at 104 percent N₁ produced no effect. However, when the No. 1 generator was put on the line, the clunking returned (*Hello! Hello!*). Recycling the generator to OFF eliminated the clunking, and the gear indicators went from unsafe to down and locked. When the No. 2 generator was cycled, no discrepancy was noted.

Later that evening, the pilot started the No. 1 engine for a maintenance turn. Several inexperienced night check troubleshooters conducted many checks, but the source of the clunking sound (*Answer, DAMMIT!*) could not be located. The only thing found was that each landing gear actuator had a jerking motion which would cease when the landing gear circuit breaker was pulled.

- Material failure of the MLG scissors switch led to the actual collapse of the gear.

- The pilot was a contributing cause factor in two ways. He failed to write up a complete gripe on the yellow sheet, and he deviated from NATOPS by allowing the gear locking pins to be removed out of sequence. Somehow this had become standard practice in the detachment, and no one had taken action to stop it.

- Maintenance supervisory personnel gave no thought to a possible MLG failure. After the pilot had reported the clunking noise to the troubleshooters, three engine turnups were made prior to the mishap. During two of them, the same symptoms were evident. On the third turnup, the clunking and gear indicator fluctuations disappeared, and the aircraft was put in an UP status. No gear dropcheck was made.

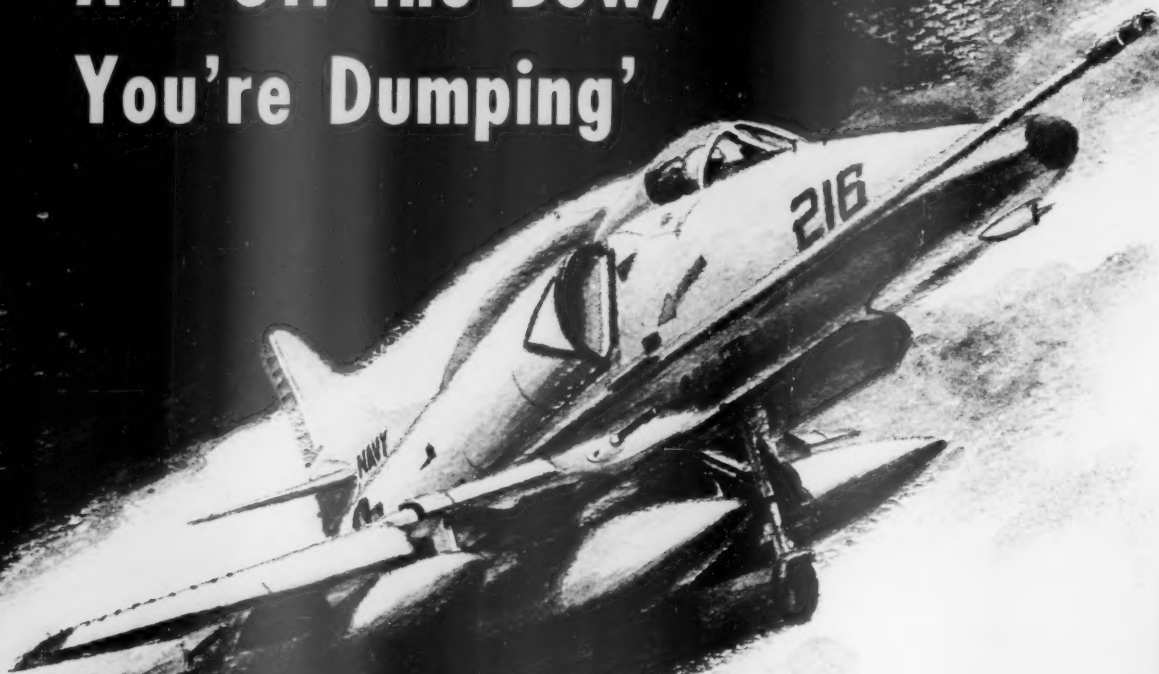
The fuel observed coming from the aircraft by the air officer was coming from the fuel tank filler hole behind the cockpit. Although it was not visible to Pri-Fly, escaping fuel caused a fire in the hump resulting in substantial damage to the airframe and electrical wiring (see photos).

Photos show fire damage in the hump area just aft of the fuel filler cap.

Flying the *Skyhawk* without the fuselage tank filler cap secured is potentially catastrophic. At present, the access door covering the filler cap can be closed with the filler cap improperly secured or missing. However, A-4 Airframe Change 508 will provide a spoiler bar that will prevent closing the access door with the fuel cap missing or unlocked.
